**ABC STORE #123 NORTHERN, CA.
INSPECTION REPORT #9900**

INSPECTION REPORT

MOISTURE TEST REPORT

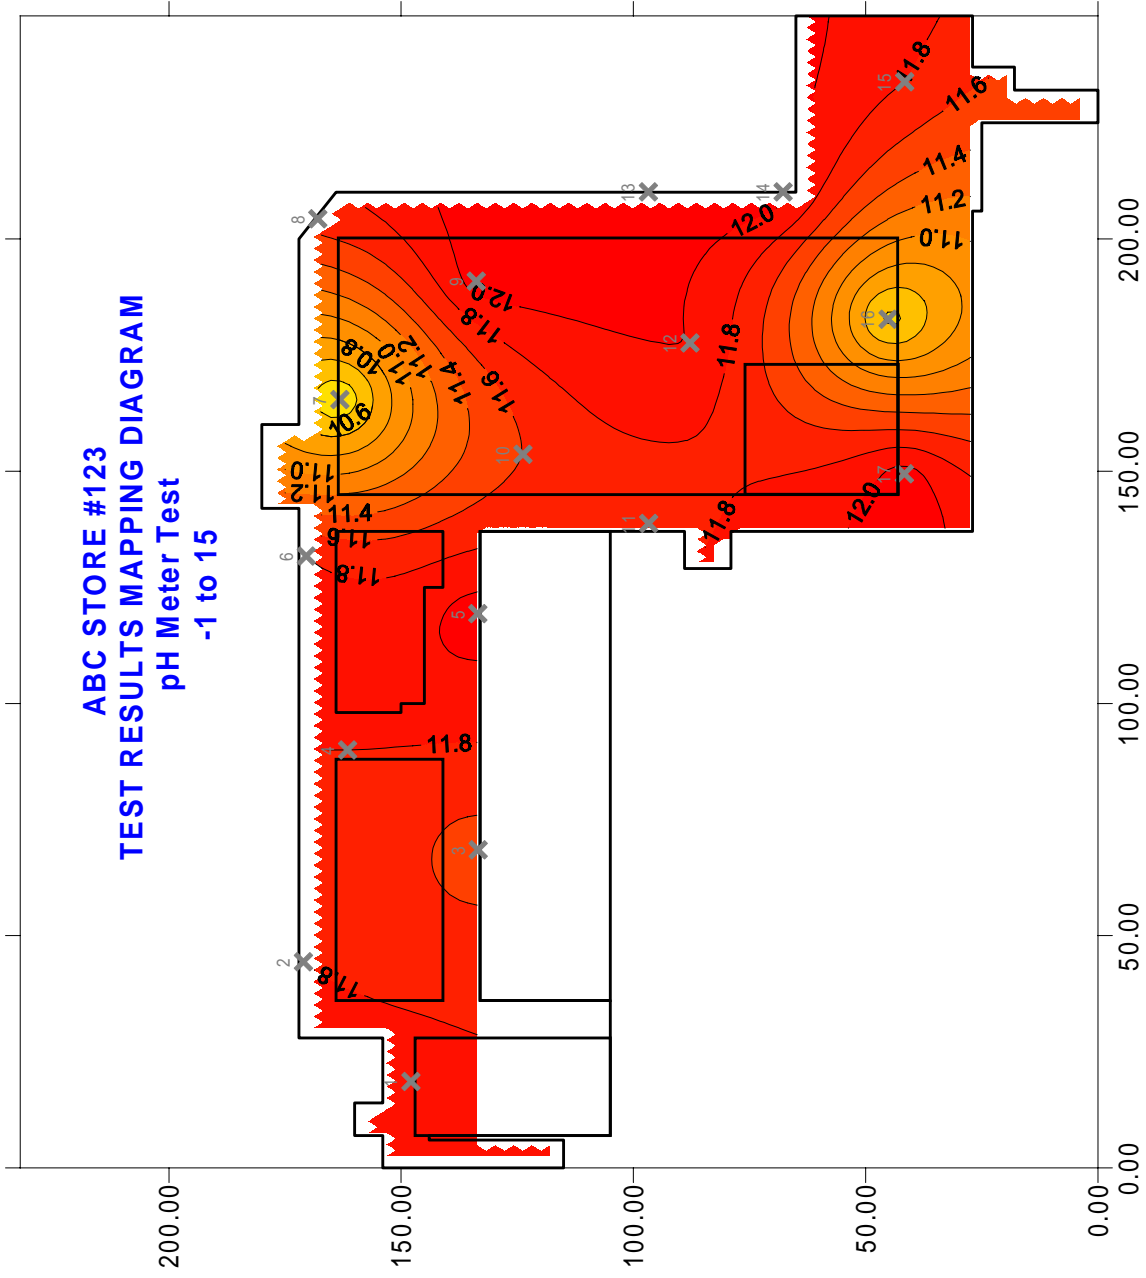
ABC STORE #123
TEST RESULTS MAPPING DIAGRAM
pH Meter Test
-1 to 15

3. A relatively high Alkalinity Condition. As moisture passes through a concrete slab, efflorescence, alkaline salts and other contaminants are carried to the surface from the ground or the concrete itself. Most floor covering Manufacturers and Organizations agree that a pH reading greater than 9 is a good indication of a potential excessive concrete moisture vapor emission problem. See “**pH Meter Reading**” **Test Results Mapping Diagram for details.**

The *Alkalinity Condition* (alkaline and/or other salt) **has** exceeded the maximum acceptable levels for the **ARMSTRONG** VCT flooring and adhesives.

It is also noted that the pH levels appear to be relatively high throughout. This may be attributable to the ‘Tile-On’ installation, which tends to trap moisture to a higher degree and draw salts to the concrete/VAT bond line. However the potential effects of the elevated pH levels appear to be minimized by the existing solvent-based, asbestos-containing cutback adhesive (additional information available upon request).

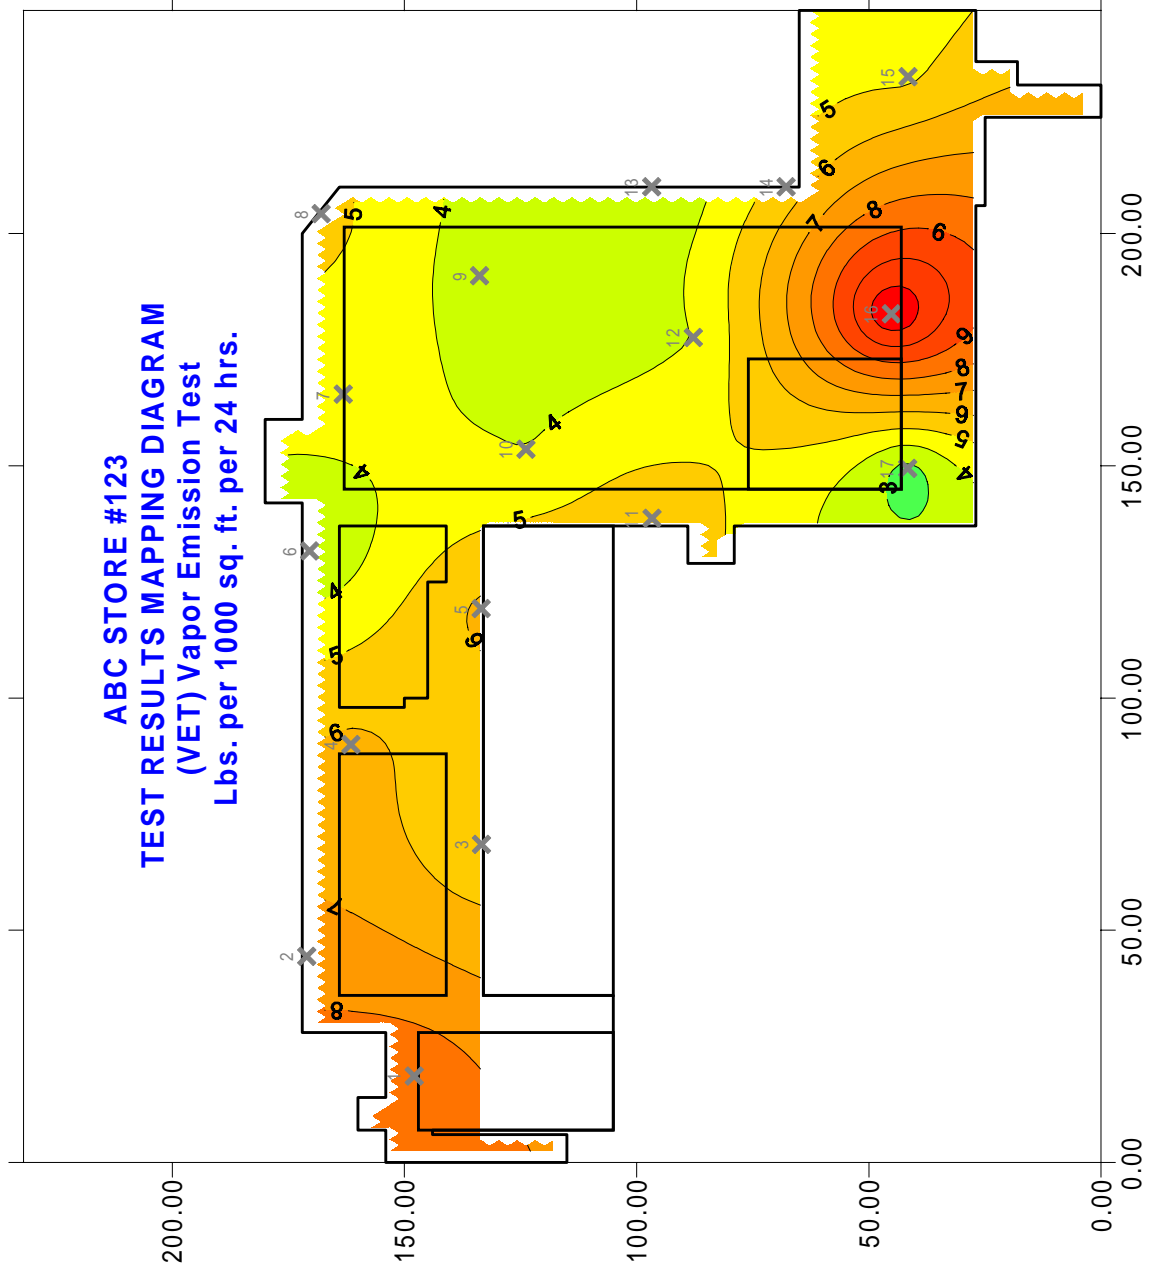
**ABC STORE #123
TEST RESULTS MAPPING DIAGRAM
(VET) Vapor Emission Test
Lbs. per 1000 sq. ft. per 24 hrs.**

4. A relatively moderate to high Dynamic Moisture Condition. Moisture vapor is radiating from concrete slab. Most Floor Covering Manufacturers and Organizations agree that an emission rate of 3.0 pounds per 1,000 square feet per 24 hours or less (based on the Anhydrous Calcium Chloride Test) is acceptable for most floor-covering products. For a few products, emission levels as high as 5.0 pounds may be acceptable. See “**Vapor Emission Test (VET)**” **Test Results Mapping Diagram for details.**

The *Dynamic Moisture Condition* (vapor emission levels) and the *Alkalinity Condition* (alkaline and/or other salt) **have** exceeded the maximum acceptable levels for the **FRIZZTILE** floor covering products and adhesives.

The *Dynamic Moisture Condition* (vapor emission levels) in most of the VCT areas tested **has not** exceeded the maximum acceptable levels for the **ARMSTRONG** VCT flooring and adhesives.

To correct the concrete slab condition and create a suitable and stable substrate to enhance long term installation success, and receive full product and installation warranties, we recommend the use of ..., ten-year warranted system ... vapor emission compliance treatment.

The existing flooring and adhesive will need to be removed. The concrete will need to be shot blasted, in addition to the joints and cracks repaired using a non-rigid joint filler system. The concrete will also need to be brought into compliance by the application of a penetrant to control soluble salts and a moisture suppressing coating to reduce vapor emissions down to the flooring manufacturer's specified levels prior to the new floor covering installation.
